#### DOT/FAA/AR-00/22

# **Corrosion and Corrosion Fatigue** of Airframe Materials

July 2000

Final Report

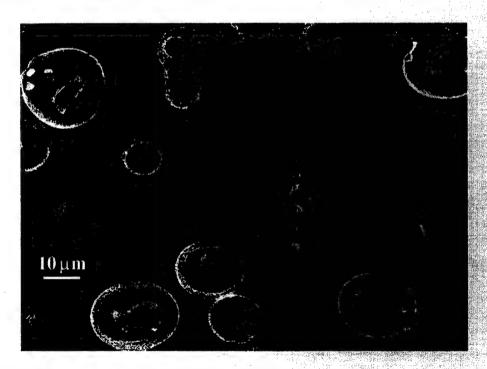
FIGURE 3-1. SEM MICROGRAPH SHOWING PITTING INDUCED BY CONSTITUENT PARTICLES IN A 2024-T3 ALUMINUM ALLOY

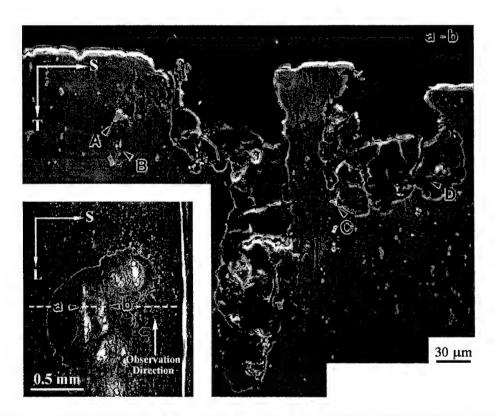
Figure 3-2 shows SEM micrographs of the cross section of pits formed from such clusters of constituent particles and an inset of the pits at the specimen surface [5,6]. The larger of the two pits is approximately 500 µm long and 70 µm wide at the surface and approximately 300 µm deep at this section. The overall shape of the pit reflects the planar distribution of constituent particles in this alloy. A comparison of the deeper severe pit in figure 3-2 with the SEM microfractograph of a fatigue crack origin (a corrosion pit represented by the dark region at the center of the microfractograph) in figure 3-3 shows that their overall features are nearly identical. The associated surface features of the fatigue origin (not shown) are also identical to those shown in the inset in figure 3-2. Similar comparisons clearly identify severe localized pits as nuclei for corrosion fatigue cracking.

FIGURE 3-2. SEM MICROGRAPH OF THE CROSS SECTION OF SEVERE CORROSION PITS IN A 2024-T3 ALUMINUM ALLOY (TS) SURFACE ALONG WITH AN INSET SHOWING THE APPEARANCE OF THE CORRESPONDING PITS ON THE LS SURFACE

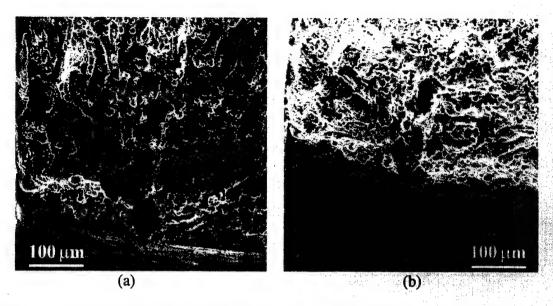
FIGURE 3-3. SEM MICROFRACTOGRAPHS OF FATIGUE FRACTURE SURFACE OF A 2024-T3 ALLOY SHOWING A SEVERE CORROSION PIT AS THE CRACK NUCLEUS: VIEWED (a) NORMAL AND (b) AT 45° TO THE FRACTURE SURFACE

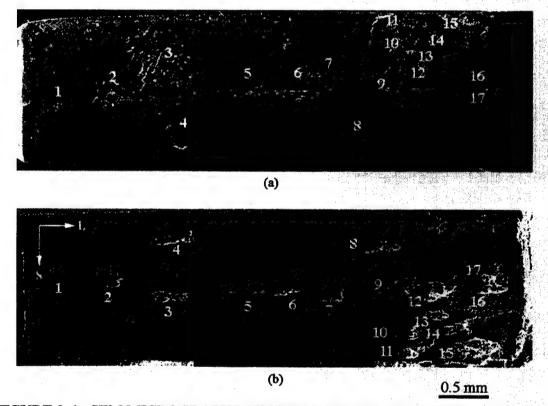
FIGURE 3-4. SEM MICROGRAPHS SHOWING SEVERE PITTING IN A 2024-T3 ALUMINUM ALLOY AFTER 500 HOURS IN 0.5M NaCl SOLUTION AT ROOM TEMPERATURE: (a) THE LS SURFACE AFTER CHEMICAL CLEANING AND (b) THE CORRESPONDING 3D REPLICA [6]

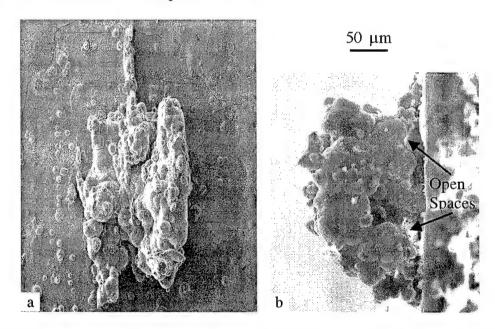
SEM micrographs of the replica of pit 2, in plan and side views, are shown at a higher magnification in figure 3-5. Figure 3-5 shows the typically complex form of a severe corrosion pit. The appearance of the replica is consistent with the postulated role of constituent particles in promoting pitting corrosion in the high-strength aluminum alloys. The individual rounded features are believed to correspond to galvanic corrosion of the matrix by the cathodic constituent particles in the alloy, and the overall planar appearance is attributed to the planar array of these particles in the rolled sheet. The open space seen in figure 3-5(b) suggests the role corrosion played around a particle (or a cluster of particles) at the surface in allowing the electrolyte to penetrate into the alloy and effect substantial corrosion beneath the surface. The 3D nature of these pits is best seen through the use of stereo imaging techniques (not shown here). The shape of the replica for pit 2 might be likened to that of one-half of a pecan or walnut with the center representing the small pit opening at the surface and the rest the cavernous pit below the surface.

FIGURE 3-5. SEM MICROGRAPHS OF THE EPOXY REPLICA OF A SEVERE CORROSION PIT IN 2024-T3 ALUMINUM ALLOY: (a) PLAN (BOTTOM) AND (b) ELEVATION (SIDE) VIEW RELATIVE TO THE ORIGINAL PIT

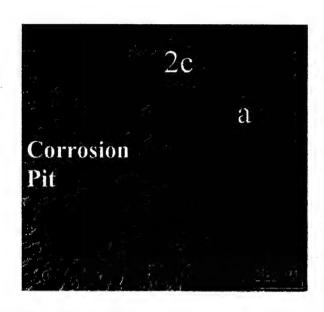
FIGURE 6-5. FRACTOGRAPH SHOWING A CORROSION PIT THAT NUCLEATED THE DOMINANT CRACK IN THE 2024-T3 ALUMINUM ALLOY AFTER 384 HOURS OF PRECORROSION

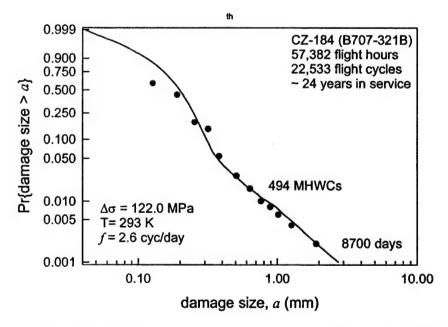
FIGURE 7-3. A COMPARISON BETWEEN THE PREDICTED AND OBSERVED PoO FOR HOLE-WALL DAMAGE IN THE LEFT-HAND LOWER WING SKINS (2024-T3 ALUMINUM ALLOY) OF THE CZ-184 AIRCRAFT

Based on reasonable values of localized corrosion and corrosion fatigue crack growth rates and by considering the primary loading from ground-air-ground (adjusted for average gust loading) cycles, the PoO of damage is estimated for each aircraft and is shown as a solid line in each of the figures. For the skins, the agreement is very encouraging. It suggests that it is feasible to estimate service performance quite well on the basis of laboratory data provided that the predictive methodology is based upon reasonable mechanistic models. On the other hand, the

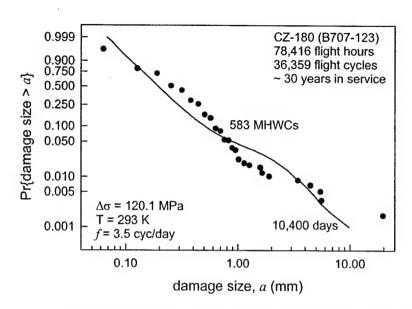
FIGURE 7-4. A COMPARISON BETWEEN THE PREDICTED AND OBSERVED PoO FOR HOLE-WALL DAMAGE IN THE LEFT-HAND LOWER WING STIFFENERS (7075-T6 ALUMINUM ALLOY) OF THE CZ-180 AIRCRAFT

agreement for the stiffeners is not as good. There are a variety of reasons for the discrepancy. The aluminum alloy for the stiffeners is 7075-T651, for which the experimental data needed to estimate the model parameters accurately is more limited than that for the 2024-T3 alloy used for the skins. The stiffeners are typically thicker than the skin, and the model may need to be adjusted accordingly. Stresses may be sufficiently different in the stiffeners so that improvements in the crack growth portion of the model may be required. The assumption of hemispherical growth of the corrosion pits may be inappropriate. It also should be noted that the model is based upon a single (dominant) damage and the measurements reflected a single value for each location; whereas, multiple cracks were observed for the fastener holes in the skins and This aspect will be discussed further in relation to the metallographic the stiffeners. examination. Consequently, further experimental testing and modeling is warranted for this application. Nevertheless, the maximum deviation from the empirical data and the estimated PoO is less than 9% for CZ-180, which may be reasonable for predictions. The maximum deviation for CZ-184, however, is at best about 21%. On the other hand, there is some error incurred from the J-STARS observation method.

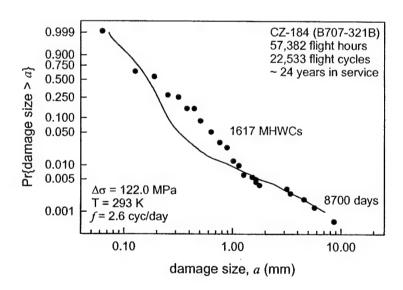
FIGURE 7-5. A COMPARISON BETWEEN THE PREDICTED AND OBSERVED PoO FOR HOLE-WALL DAMAGE IN THE LEFT-HAND LOWER WING STIFFENERS (7075-T6 ALUMINUM ALLOY) OF THE CZ-184 AIRCRAFT

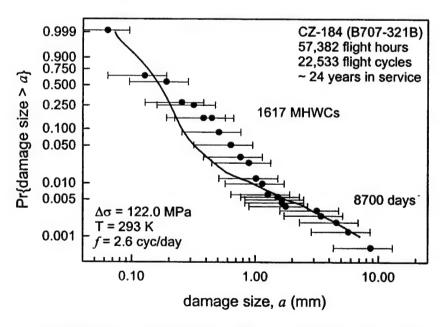
The uncertainty in measurement for the stiffeners may be estimated from available data on the skins. For 42 selected fastener holes from the CZ-184 skin, the crack lengths were estimated by employing higher resolution optical microscopy, described below, and the average relative difference exceeds 75%. Figure 7-6 duplicates figure 7-5 with the addition of error bars for the reported crack lengths, assuming that the measurement error was 50%. This leads to a relatively broad error band for the data. For this scenario the predicted PoO falls within all of the error bounds. Even so, the prediction does not appear to be satisfactory. Again, further analyses are warranted. Thus, the viability of the model for estimating the PoO has been established in terms of the reported teardown data for the wing skins, but caution must be exercised for the stiffeners.

FIGURE 7-6. A COMPARISON BETWEEN THE PREDICTED AND OBSERVED PoO WITH ESTIMATED ERROR BARS FOR THE DATA FOR HOLE-WALL DAMAGE IN THE LEFT-HAND LOWER WING STIFFENERS OF THE CZ-184 AIRCRAFT

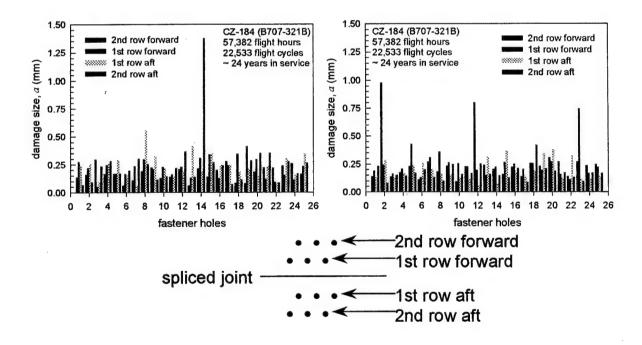
The availability of a validated predictive model for PoO provides a rational method for estimating the distribution of damage for use in MSD analyses. The approach and methodology is illustrated by using the predicted PoO distribution for the CZ-184 aircraft, see figure 7-3. Using Monte Carlo simulation for the largest crack length in each fastener hole, the damage distribution for a collection of fastener holes may be estimated. Damage from hole to hole, as well as at the two highly stressed sides of each hole, is considered to be statistically independent. Two such distributions, each representing one simulation, are shown in figure 7-7 for 100 fastener holes arranged in four rows along a spliced joint. Each simulation may represent different locations in a single aircraft or the same location for different aircraft under comparable service conditions. From these figures, it is seen that different levels of damage are possible, and critical locations may be identified through the size and clustering of damage at a given stage in service. To illustrate the effect of considering larger populations of holes, a simulation for 1,000 holes is shown in figure 7-8. Note that the extreme values, i.e., larger size damage, in the distribution are considerably more prominent, and a number of critical areas can be identified readily. These illustrations demonstrate the value of this approach in airworthiness assurance and management of civil and military aircraft.

FIGURE 7-7. VARIATIONS IN THE SIMULATED DAMAGE DISTRIBUTIONS FOR 100 FASTENER HOLES BASED ON THE PoO FOR THE SKIN OF THE CZ-184 AIRCRAFT

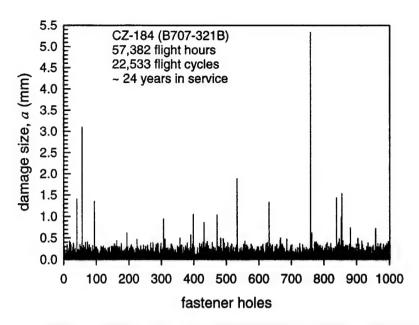
FIGURE 7-8. SIMULATED DAMAGE DISTRIBUTION FOR 1,000 FASTENER HOLES BASED ON THE POO FOR THE SKIN OF THE CZ-184 AIRCRAFT

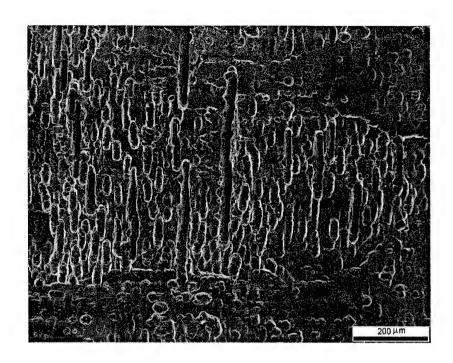
FIGURE 7-9. SEM MICROGRAPH OF CORROSION-RELATED DISTRIBUTED DAMAGE AT HOLE NO. 54 IN PANEL B2-2-2 OF THE CZ-184 AIRCRAFT

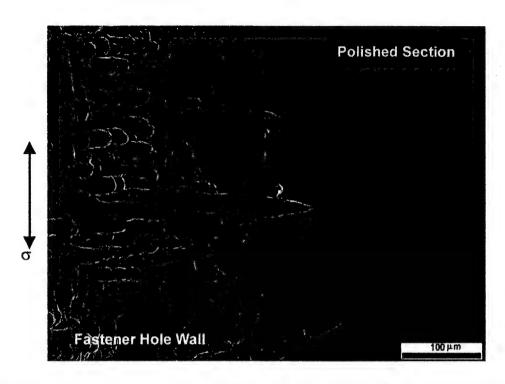
FIGURE 7-10. SEM MICROGRAPH OF A SECTION THROUGH AN ELONGATED DAMAGE AT HOLE NO. 77 IN WING PANEL B3-2-5 OF THE CZ-184 AIRCRAFT SHOWING CORROSION ATTACK OF THE FATIGUE CRACK

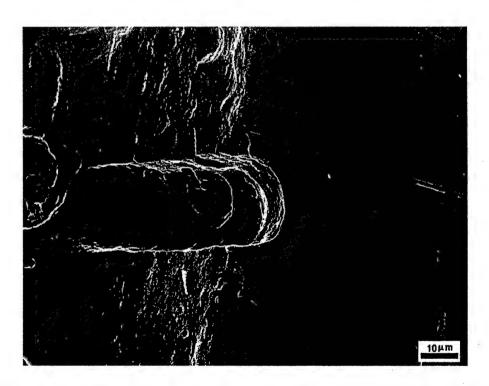
FIGURE 7-11. SEM MICROGRAPH OF A THROUGH SECTION OF A SHALLOW DAMAGE AT HOLE NO. 77 IN WING PANEL B3-2-5 OF THE CZ-184 AIRCRAFT SUGGESTING THAT THE CRACK WAS DISSOLVED BY CORROSION

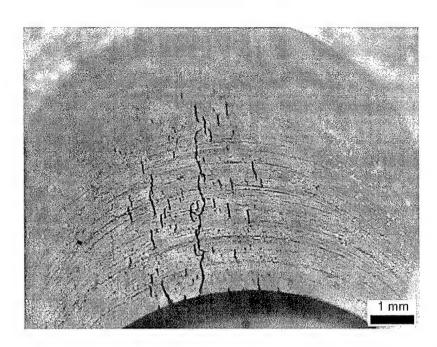
FIGURE 7-12. OPTICAL MICROGRAPH OF A HIGHLY STRESSED REGION OF HOLE NO. 107 IN WING PANEL B3-2-2 OF THE CZ-184 AIRCRAFT SHOWING EXTENSIVE CORROSION FATIGUE CRACKING

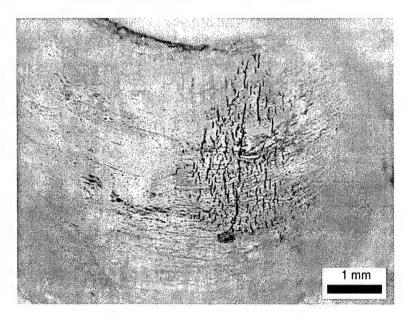
FIGURE 7-13. OPTICAL MICROGRAPH OF A HIGHLY STRESSED REGION OF HOLE NO. 103 IN WING PANEL B3-2-2 OF THE CZ-184 AIRCRAFT SHOWING EXTENSIVE CORROSION FATIGUE CRACKING

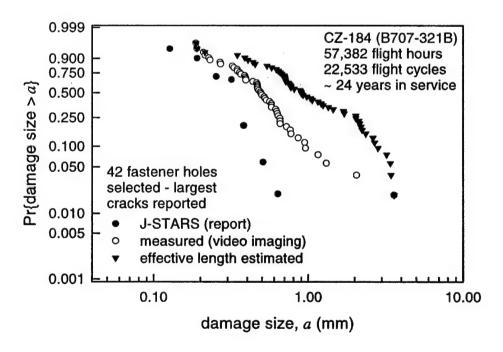
The first issue to consider is the accuracy of the values in the J-STARS report. As mentioned above, a large number of holes were inspected, but with only a 20× magnifying lens. This activity is very tedious and probably not especially accurate based on the magnification and the difficult angles required to view the cracks. Figure 7-14 shows the damage sizes for 42 holes that were selected because the J-STARS report indicated MHWCs of significant length. The graph also includes the sizes measured with the aid of the Hi-Scope video imaging system at a magnification of 50 to 150× described above and estimated effective crack lengths to capture the entirety of the damage region. Clearly, there are significant differences between the three data sets. In fact, the average value for each of the three sets is 0.36 mm (0.014 in), 0.61 mm (0.024 in), and 1.43 mm (0.056 in), respectively. The range of the data, from left to right, increases indicating greater scatter. This may be an artifact of the methodologies in that the data from the J-STARS report are grouped, and the estimation of effective lengths was somewhat subjective (see, for example, figure 7-13). Nevertheless, the overriding conclusion is that, if possible and feasible, higher-resolution microscopy is needed to accurately characterize the damage in fastener holes.

FIGURE 7-14. COMPARISON OF THE PoO FOR THE MAXIMUM MHWC LENGTHS REPORTED BY J-STARS, MEASURED USING VIDEO IMAGING MICROSCOPY, AND EFFECTIVE LENGTH ESTIMATED FROM THE OVERALL EXTENT OF THE FIELD OF DAMAGE FOR SELECTED HOLES FROM THE CZ-184 AIRCRAFT

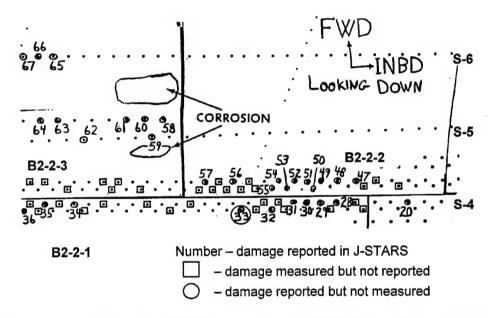
In an attempt to complete a carefully formulated statistical analysis for a significant number of fastener holes, 110 holes from B2-2 along S-4 were observed with the Hi-Scope system. Figure 7-15 is taken from figure B2-2 in [18]. The holes considered are those in the two rows forward and aft of the spliced joint in panels B2-2-1 to B2-2-3. The holes that have been circled and numbered are those in which damage was observed by the J-STARS analyses. Thirty-two additional holes with damage, circumscribed by a square, were found to have damage using the Hi-Scope, but were not included in the J-STARS report. Hole No. 33 was reported to have damage, but none was found in the Hi-Scope examination. Clearly, the fraction of holes with damage in this section along this stiffener is quite high, with 51 out of the 110 holes (not including #33) having experienced damage. A contributing factor to this observation is that steel fasteners were used with 2024-T3 aluminum alloy skin along S-4. Galvanic coupling between the fasteners and the skin, in the presence of a deleterious environment, would enhance the nucleation and growth of corrosion. In passing, notice that J-STARS inspectors highlighted two patches of corrosion observed on the surface of the skin.

FIGURE 7-15. A PORTION OF SECTION 2 ALONG STIFFENER 4 FROM THE CZ-184 AIRCRAFT FOR WHICH MICROSCOPY AND STATISTICAL ANALYSES ARE MADE

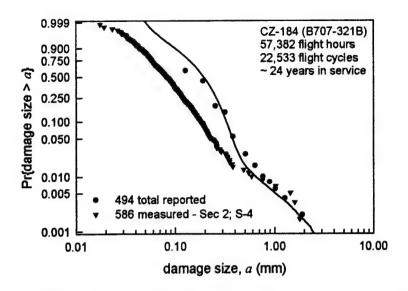
Figure 7-16 shows the empirical PoO from the J-STARS report, the predicted PoO for that data, and the empirical PoO for the MHWCs from the 110 holes shown in figure 7-15. Since the new data lie to the left of the other, the position of the solid line suggests that it overestimated distribution and severity of damage, although the actual extent of damage was greater in terms of the number of fastener holes affected. The discrepancy reflects principally the difference in measurement resolution and secondarily measurement procedure. In the J-STARS examinations, the smallest value reported was a = 0.127 mm for all of the panels, whereas the new measurements were as small as a = 0.015 mm. Also, the J-STARS report included only the "largest" crack found on each side of a hole. The new measurements, on the other hand, considered every resolvable crack in each hole along S-4 in panel B2-2. Consequently, care should be exercised in the application of the proposed model.

FIGURE 7-16. COMPARISON OF THE PoO FOR ALL MHWC LENGTHS REPORTED BY J-STARS AND ALL OF THOSE MEASURED USING VIDEO IMAGING MICROSCOPY FOR 110 HOLES FROM SECTION 2 ALONG STIFFENER 4 FROM THE CZ-184 AIRCRAFT

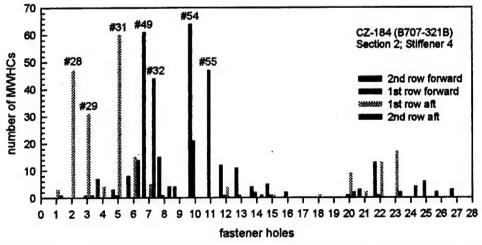
Figure 7-17 shows the density of the MHWCs for the 110 holes along S-4 shown in figure 7-15, obtained using video imaging microscopy. The holes are numbered right to left, similar to the J-STARS enumeration; however, each of the four rows are numbered separately. The holes with the most severe damage are also labeled for easy reference. There are three holes with at least 60 cracks and another three with at least 40. Furthermore, all six of these holes are rather close, as indicated on figure 7-15. Figure 7-18 shows a plot of the largest measured cracks along S-4. The pattern is similar to the estimated distributions shown in figures 7-7 and 7-8 and attests to the efficacy of the approach for estimating MSD. It is also closely related to the numbers of cracks per fastener hole shown in figure 7-17 and suggests the potential link-up of the MHWCs leading to MSD.

FIGURE 7-17. DENSITY OF MEASURED CRACKS PER FASTENER HOLE FOR SECTION 2; STIFFENER 4 FROM THE CZ-184 AIRCRAFT

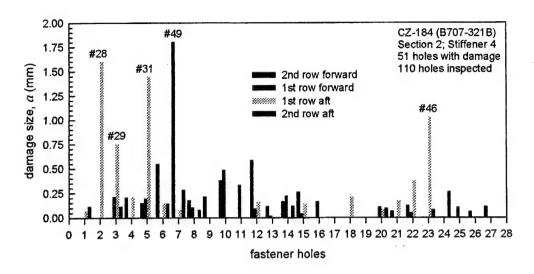
FIGURE 7-18. DAMAGE DISTRIBUTION OF MAXIMUM CRACK LENGTHS FOR 110 FASTENER HOLES FROM SECTION 2 ALONG STIFFENER 4 FROM THE CZ-184 AIRCRAFT
